CORNER RECORD

Document Number 3527-34-94

Brief Legal Description CENTERLINE MONUMENT MAMMOTH VISTA NO. 3, S. 34, T. 3. S., R. 27E MDRBM

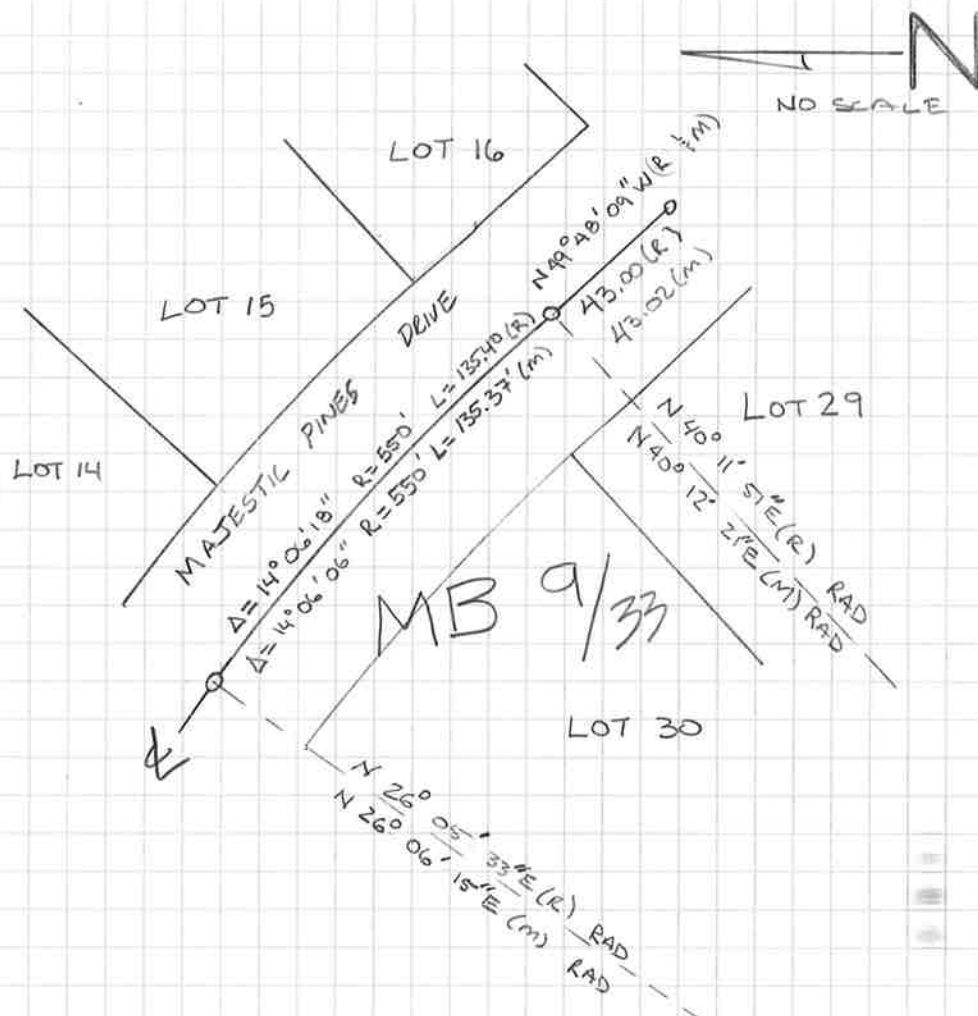
FND 2" IRON PIPES ON CENTERLINE @ THE BEGINNING & ENDING OF THE
TANGENT NORTHEAST OF LOT 29 and @ THE BEGINNING OF CURVE NORTHEAST
OF LOT 30 LEADING INTO ABOVE MENTIONED TANGENT. MON'S TIED OUT.

A description of the physical condition of the monument as found and as set or reset: SET 2" PIPES w/ WASHERS
TAGGED "LS4587" AS A DIRECT REPLACEMENT OF FND MON'S AS DESCRIBED ABOVE.
DESTROYED DURING ROAD CONSTRUCTION

- DIRECT REPLACEMENT OF
FND 2" IRON PIPES RCE 15160
DESTROYED DURING ROAD
CONSTRUCTION WITH 2" PK
WASHER "LS4587"

THE BEARING N 49°48'09"W BETWEEN
TWO FND MONUMENTS ON MAJESTIC
PINES DRIVE.
